# **Mandatory Ground**

## **ELEVATORS**

**If your elevators are not in compliance with the following report GROUND YOUR AIRCRAFT**

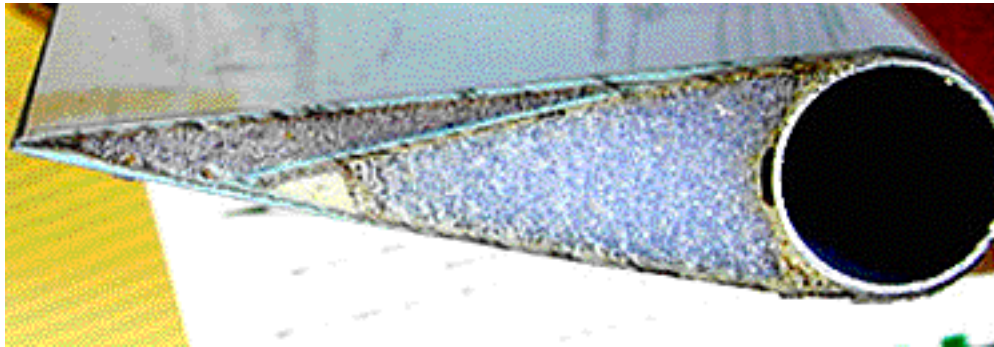
If you own an older Varieze, built with the original short chord elevator that has been modified to the "new" longer chord, in other words, an elevator within an elevator, (see photo).

**Ground your aircraft; do not fly it again until you have fabricated new elevators with the correct shape, size and balance.**
